4th SADC GROUNDWATER CONFERENCE

Investigating groundwater contamination in St. Mary's suburb of Chitungwiza, Zimbabwe

M. Chisero*, Z. Hoko, S. Misi, W. Gumindoga

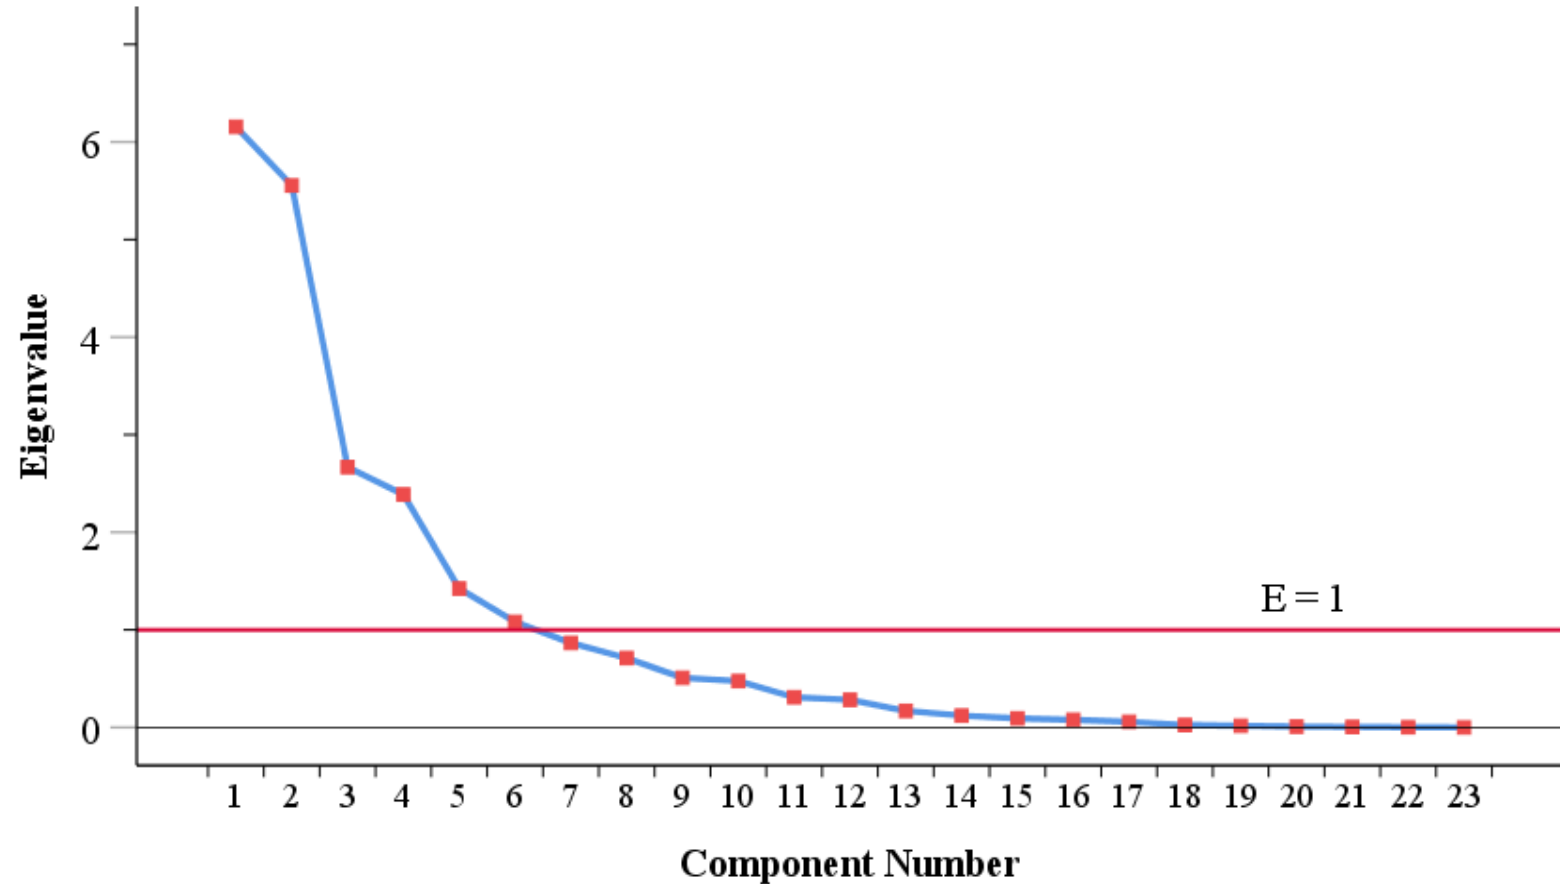
Extraction of key parameters using the PCA

- ❑ PCA used for dimensional reduction.
- ❑ 6 PCs extracted, 84% of the cumulative variance.
- ❑ PC1 had 27 %, PC2 had 24%, PC3 12%, PC4 10%, PC5 6% & PC6 5%.
- ❑ predominant parameters: temperature, EC, TSS, turbidity, chloride, magnesium, phosphates, TC, FC, nitrate and total hardness.
