5TH SADC GROUNDWATER CONFERENCE

MAPPING THE EXTENT OF WATER SALINITY IN THE SHORELINE AQUIFERS: LAKE CHILWA BASIN, MALAWI.

16th November 2022

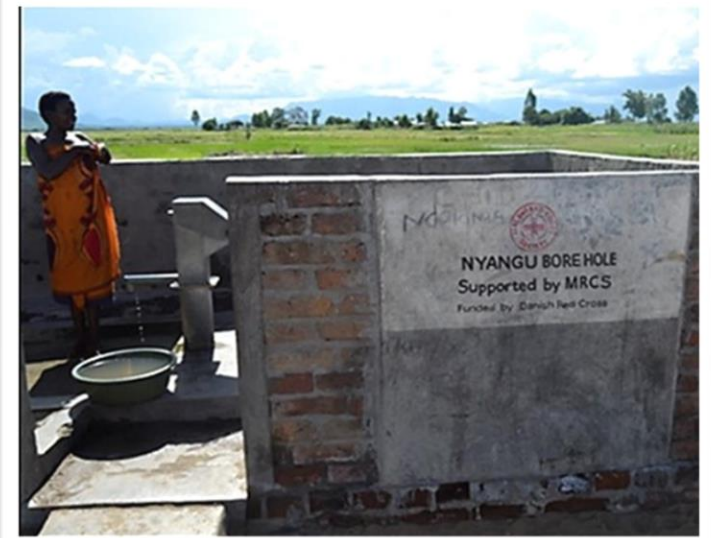
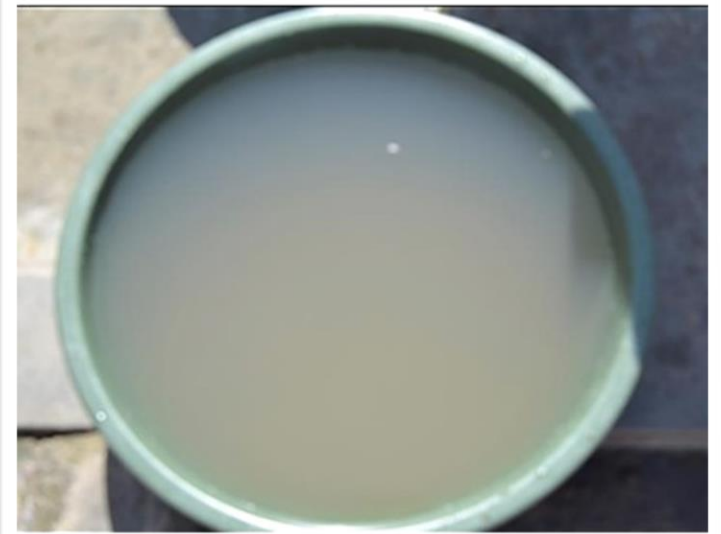
- Most of the groundwater sources on the shores of Lake Chilwa (Kachulu Village) are saline. This has largely been attributed to the arid climate in the region.
- The extent to which groundwater interaction processes including saltwater intrusion from the lake are not well understood.

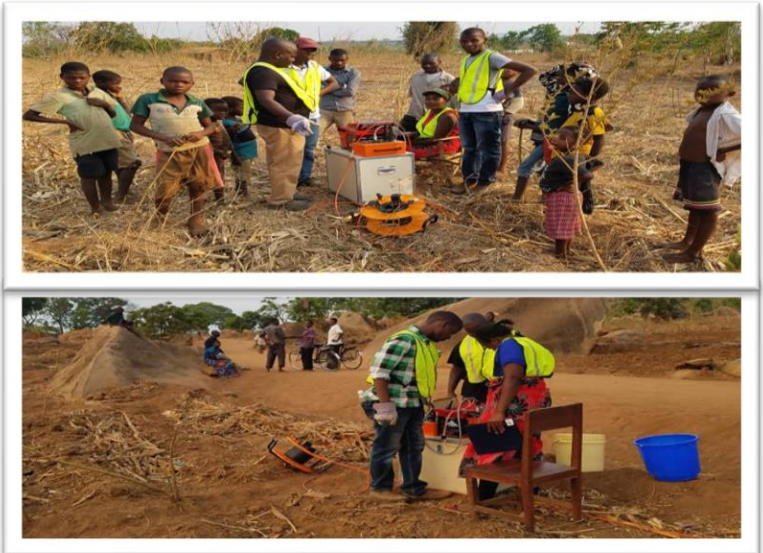
- We conducted a 2D Electrical Resistivity Tomography (ERT) using ABEM SAS 1000 terameter and a Wenner electrode configuration array (Baharuddin et al, 2013)
- Data was collected from two profile. Profile one measured from north-west going south-east at 520m and profile two measured progressing into the mainland from north-east going south-west at 720m
- The data was processed using a Res2DINV software and the ERT inversions was produced.
- Arcgis - used for map preparations
